Journal of Rock Mechanics and Geotechnical Engineering

A case history study on causation of the landslide in Santa Clara, California, USA

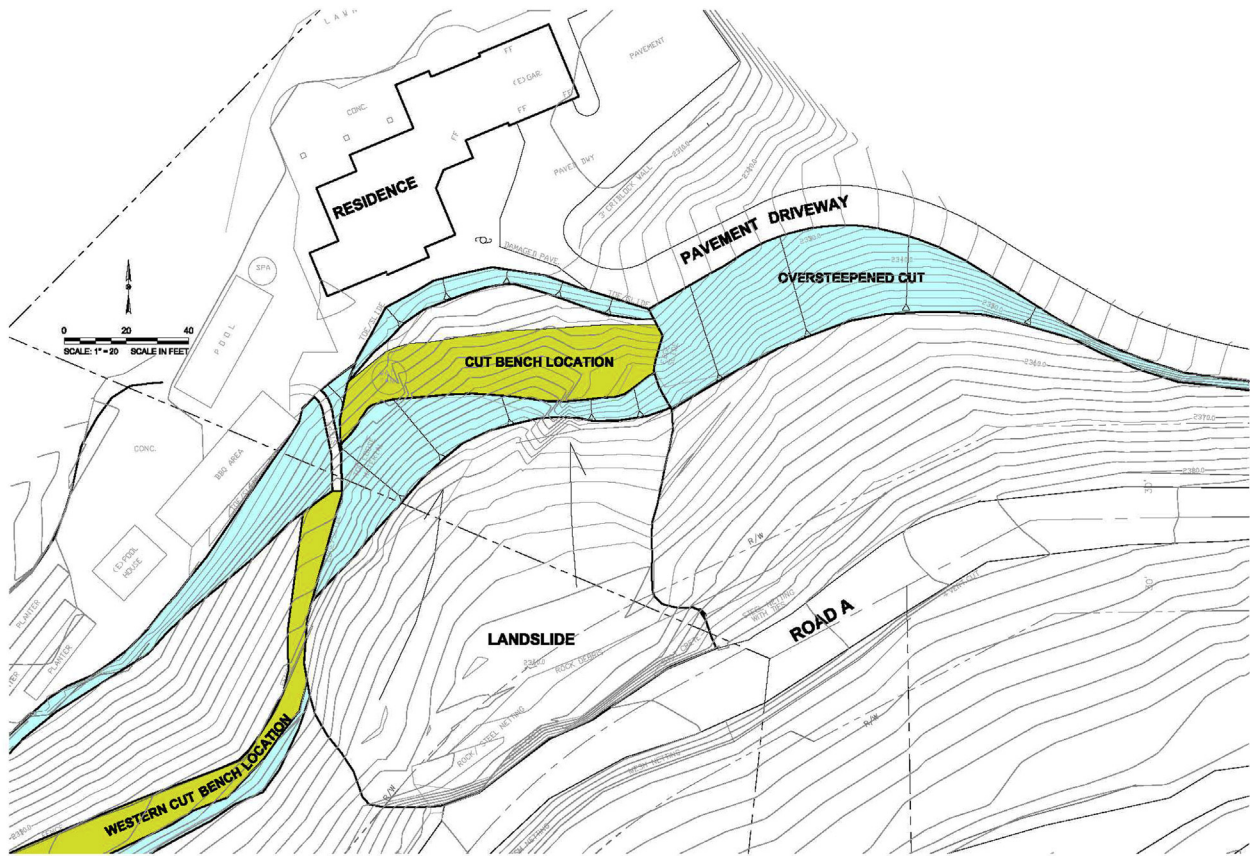
Fig. 2. Site plan.

The topographic contours within the limits of the landslide as shown in Fig. 2 depict the topography of the body of the landslide in 2012 after the geomorphic expression of the slope failure had been altered by toe cuts, pioneered access routes for the subsurface exploration equipment in addition to activities related to the soil nail wall construction along the landslide's headscarp. The surveyed topographic contours from the July 2011 topographic survey conducted by Westfall were superimposed to the area of the water tank and its cut bench. The survey was performed after the failure but before the subsurface exploration took place to show the extent and magnitude of cut associated with the water tank construction.

Although this noted level bench and associated cut slope had been displaced northward as the landslide moved downslope, their relative measurements and gradients remained largely intact.

Beyond the western landslide margin of the landslide to the west, the toe of the slope abutting the created level area where the sheds and planters are situated has been cut steeply to a near-vertical gradient that varied in vertical height from about 0.9 m to 2.4 m. A concrete stairway that was cut ascending the slope is present abutting the northwest corner of the landslide at the western landslide margin. Near mid-height of the slope to the west of the landslide, another cut bench that measured up to about 6.1 m

in width extends westward across the slope between the concrete stairway and the western end of the created level area where the shed and the noted planters are located. The extension of the western cut bench has resulted in an associated slope that is up to 3 m in vertical height and a relatively steep 0.5H:1V to 1H:1V gradient.

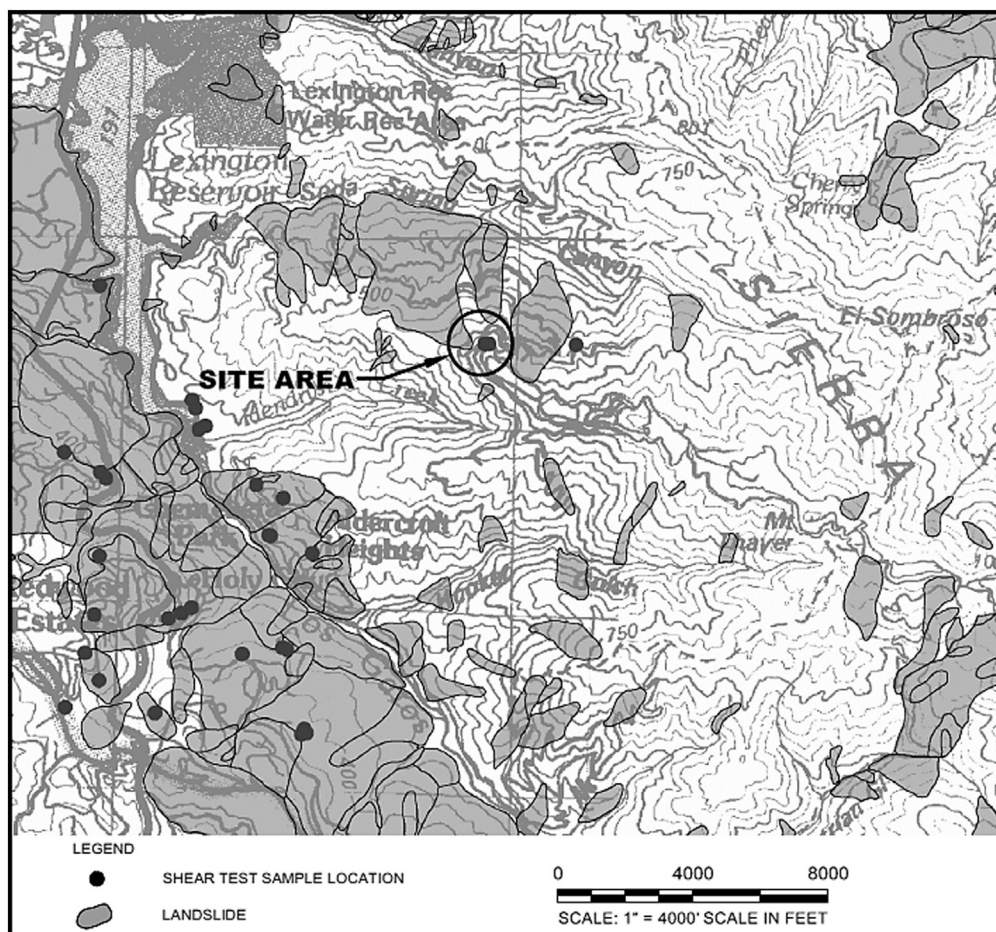
Fig. 3. Landslide inventory map (After CGS, 2002a).

The Seismic Hazard Zonation Report 069 for the Los Gatos Quadrangle, prepared by the CGS (2002a), presents a landslide inventory map of the area and it shows large-scale landslide deposits immediately to the east, north and west of the site. The above-noted swale to the west of the site is shown to be entirely underlain by a large landslide complex. The site area is shown to be along the head margin of the noted large landslide complex. The CGS's landslide inventory map is presented herein as Fig. 3.

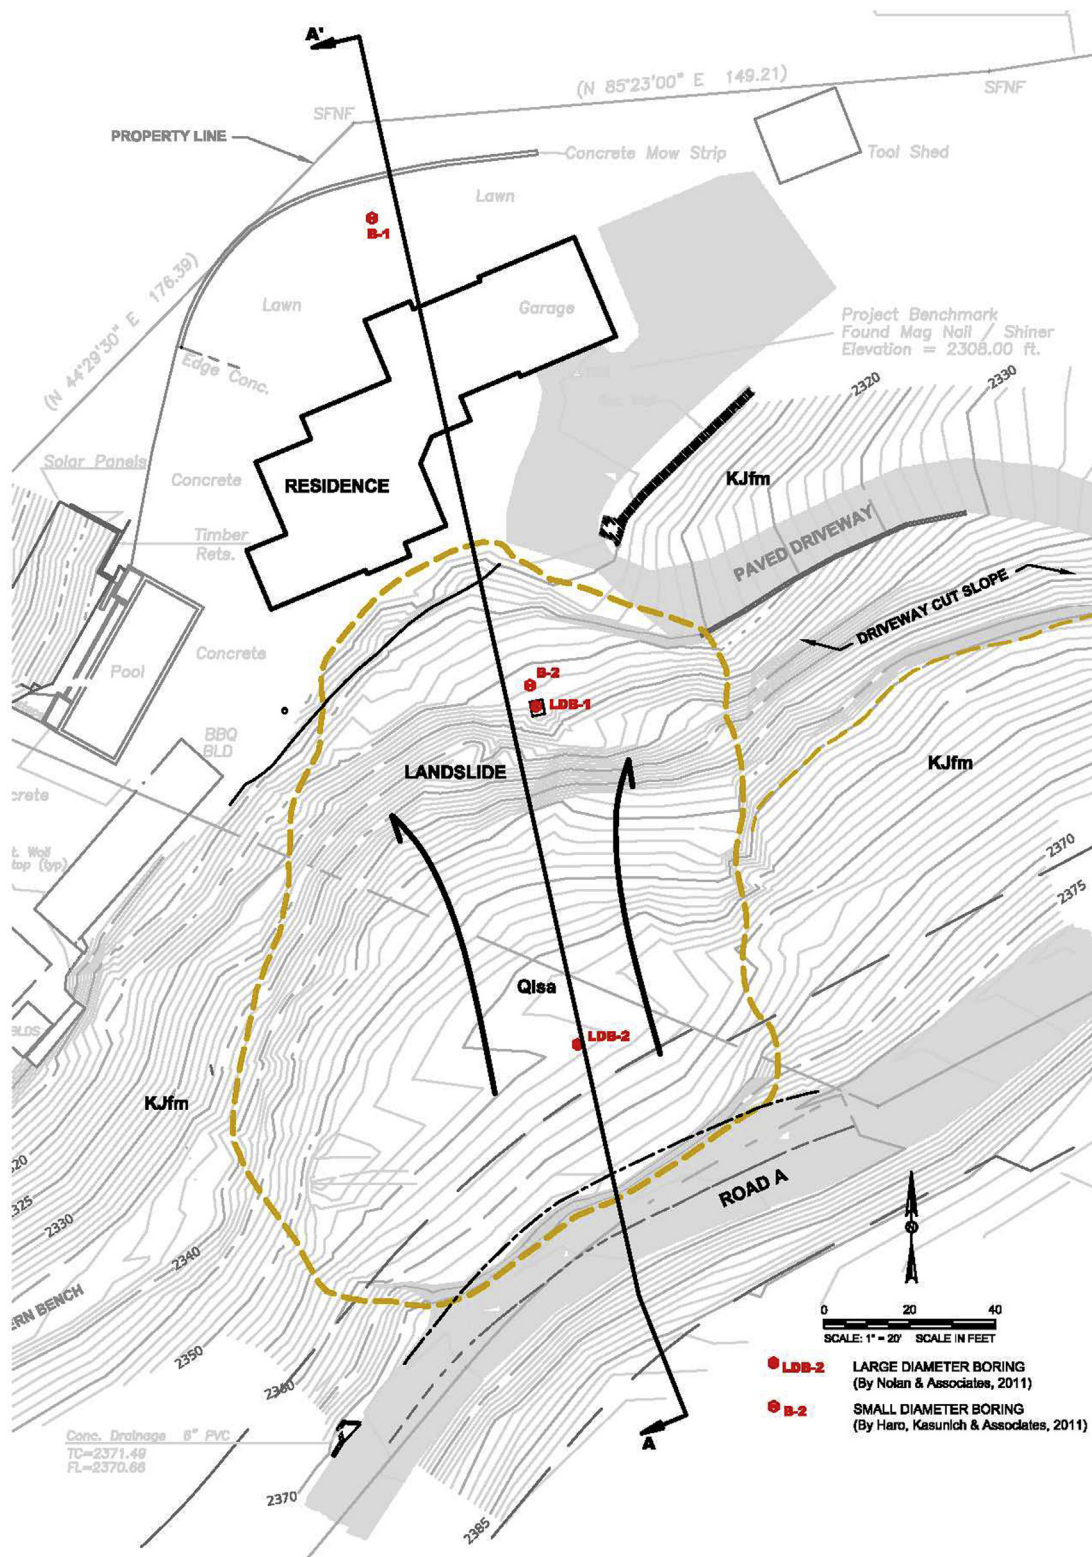
Fig. 4. Site map with boring locations.

In 2011, Consultant A performed a subsurface exploration program consisting of three exploratory borings near the lower and upper portions of the landslide, respectively. The locations of these borings are shown in Fig. 4. The subsurface exploration encountered pervasively sheared Franciscan Complex rocks consisting of sandstone and basalt in borehole LDB-1 and predominantly sandstone in LDB-2. Free groundwater was encountered in B-2 and LDB-1 at about 3.7–4 m below the ground surface. Based on their field investigation, a cross-section with interpreted subsurface conditions was developed by Consultant A for their numerical modeling as shown in Fig. 5.

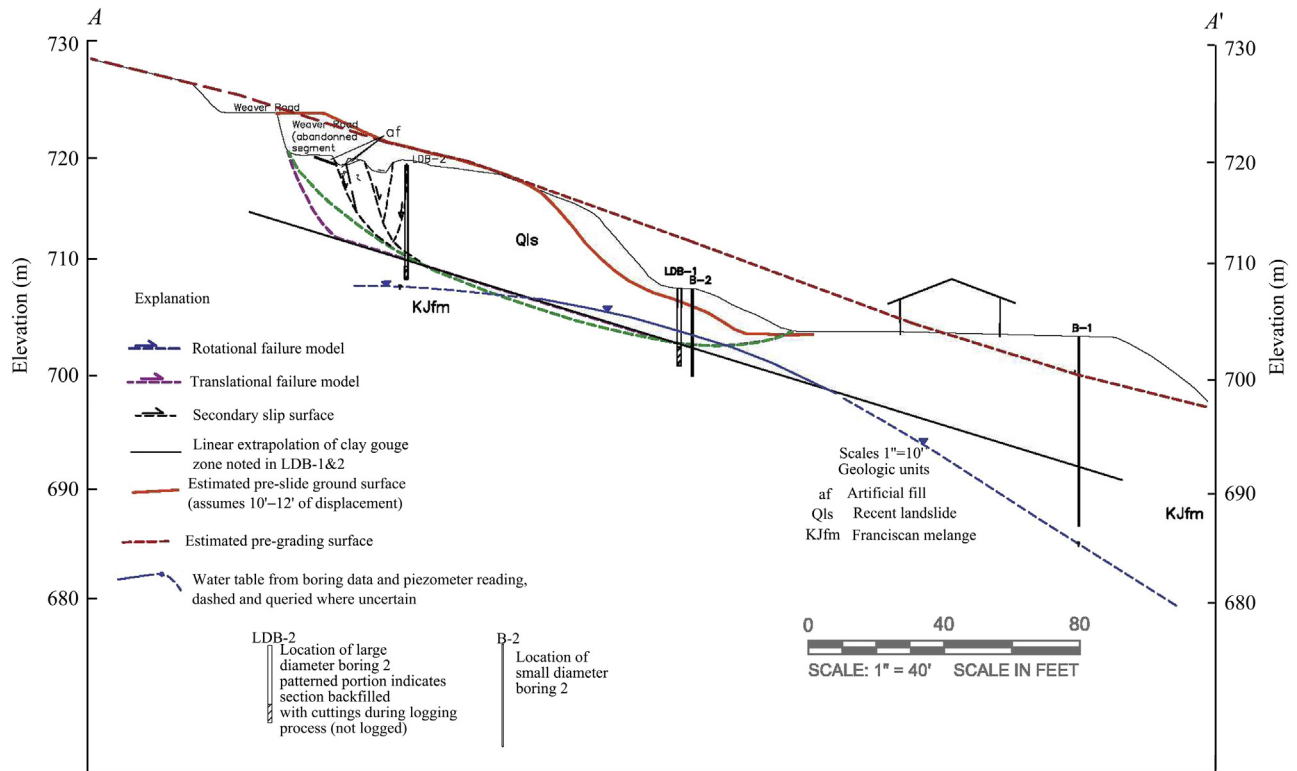
Fig. 5. Cross-section A–A'.

We performed their numerical modeling of slope stability on the cross-section as shown in Fig. 5. It should be noted that Consultant A used the same cross-section for their slope stability evaluation. Unlike Consultant A, however, we have carried out their numerical modeling as follows:

- (1) A zone of 0.15-m thick basal failure plane consisting of clayey gouge extending from the headscarp to the toe of the landslide was modeled.
- (2) Two failure modes were modeled, including a rotational slip surface and a translational slip surface. The definitions of the rotational and translational slip surfaces are shown in Fig. 5 as recommended by Consultant A.

It is worth noting that the ground surfaces that correspond to the latter two stages were derived from the cross-section shown in Fig. 5 while the first stage was generated by extending a straight line from the pre-failure toe to the top of the water tank cut slope. The post-failure ground surface topography was the only condition

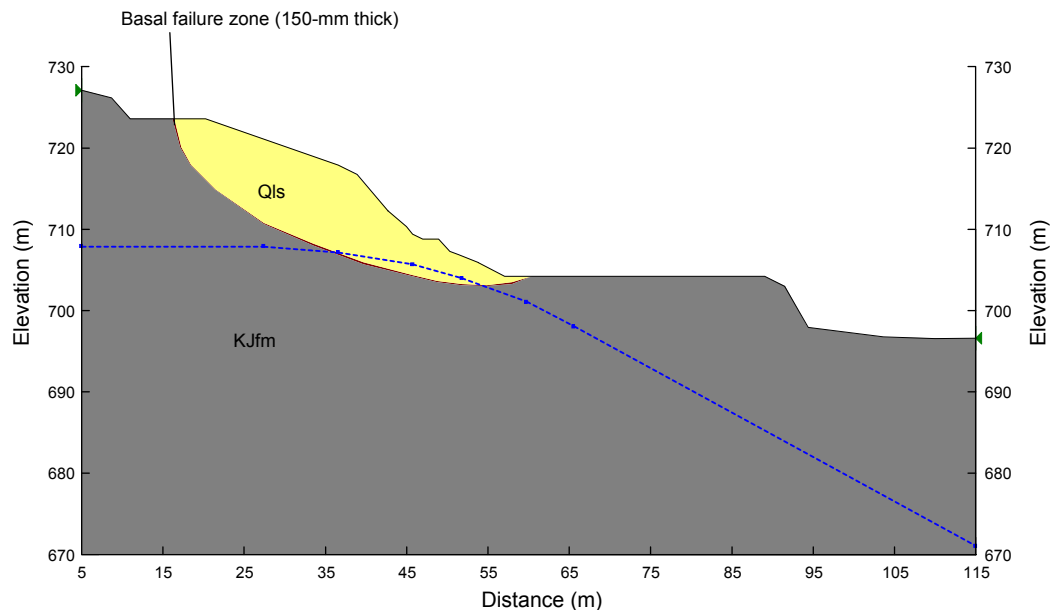
Fig. 6. Slope/W model for back calculation of frictional angle of basal failure plane.

than 1.0. The Slope/W model developed for back-calculating the frictional angle of the basal failure plane is shown in Fig. 6. Under these conditions, a FOS of 0.99 was assumed for the pre-failure and post-cut topography to back calculate the frictional angle of the basal failure plane. Using the back-calculated frictional angle of the basal failure plane, the values of FOS for pre-failure and pre-cut and post-failure conditions were evaluated. The results of stability analyses are summarized in Table 2. The results indicate that the pre-failure and pre-cut condition was marginally stable (FOS of 1.06 or 1.04) prior to the 2002 grading. As shown in Table 2, the impact of the hillside grading reduced the FOS by 0.07 (7%, i.e. from FOS of 1.06 to 0.99) for a rotational-type failure slip surface and by 0.05 (5%, i.e. from FOS of 1.04 to 0.99) for a translational-type failure slip surface.
